Corrosion behaviour of a self-pierce rivet joint of carbon-fibre reinforced plastic-laminate and EN AW-6060-T6 subjected to laboratory and outdoor exposure tests

CFK-Valley Stade Convention 2013

Authors: Prof. Dr.-Ing. L. Krüger, Dipl.-Nat. M. Mandel

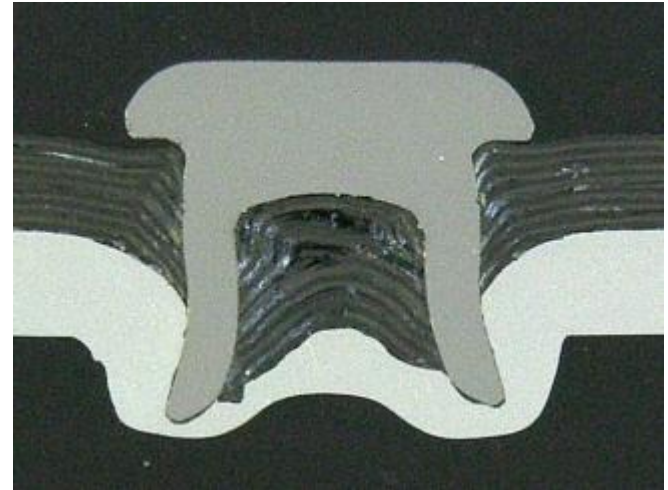
Galvanic Corrosion

- in contact to an electrolyte a galvanic element is formed
- CFRP is the cathode
- EN AW-6060-T6 and rivet are the anodes

- Rivet supplies electric conduction between

→ Formation of a galvanic element in the presence of an electrolyte

Anodes: EN AW-6060-T6, Almac[®]-coated rivet

Cathode: CFRP-laminate

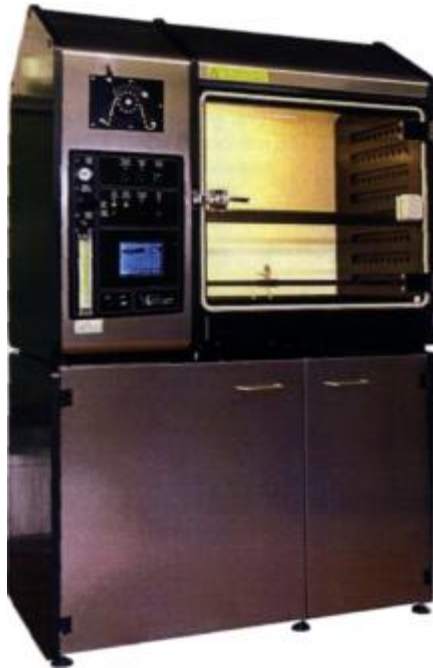
Indoor

Climatic conditions defined
by controller

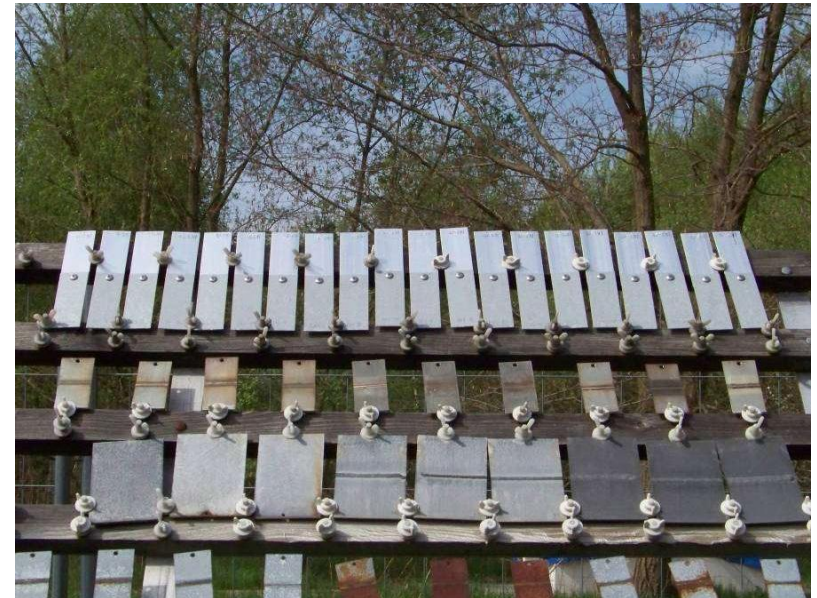
Outdoor

Climatic conditions defined
by environment and controller

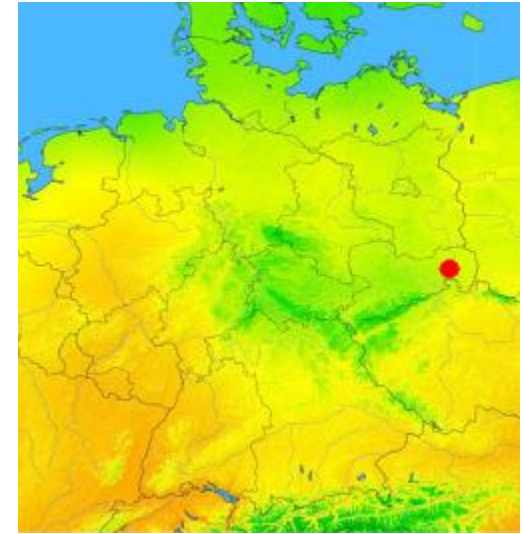
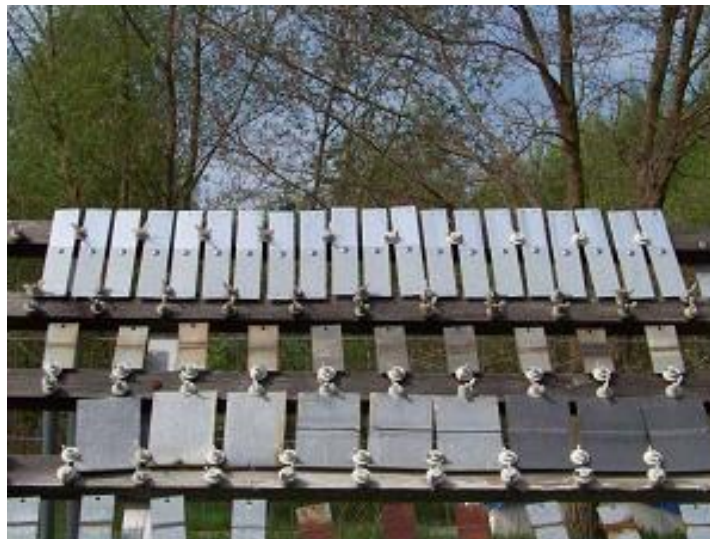
Outdoor – VDA 621-414

- Climatic conditions of Dresden
- Corrosion category C2/C3
- Weekly sprayed with 3wt% sodium chloride solution

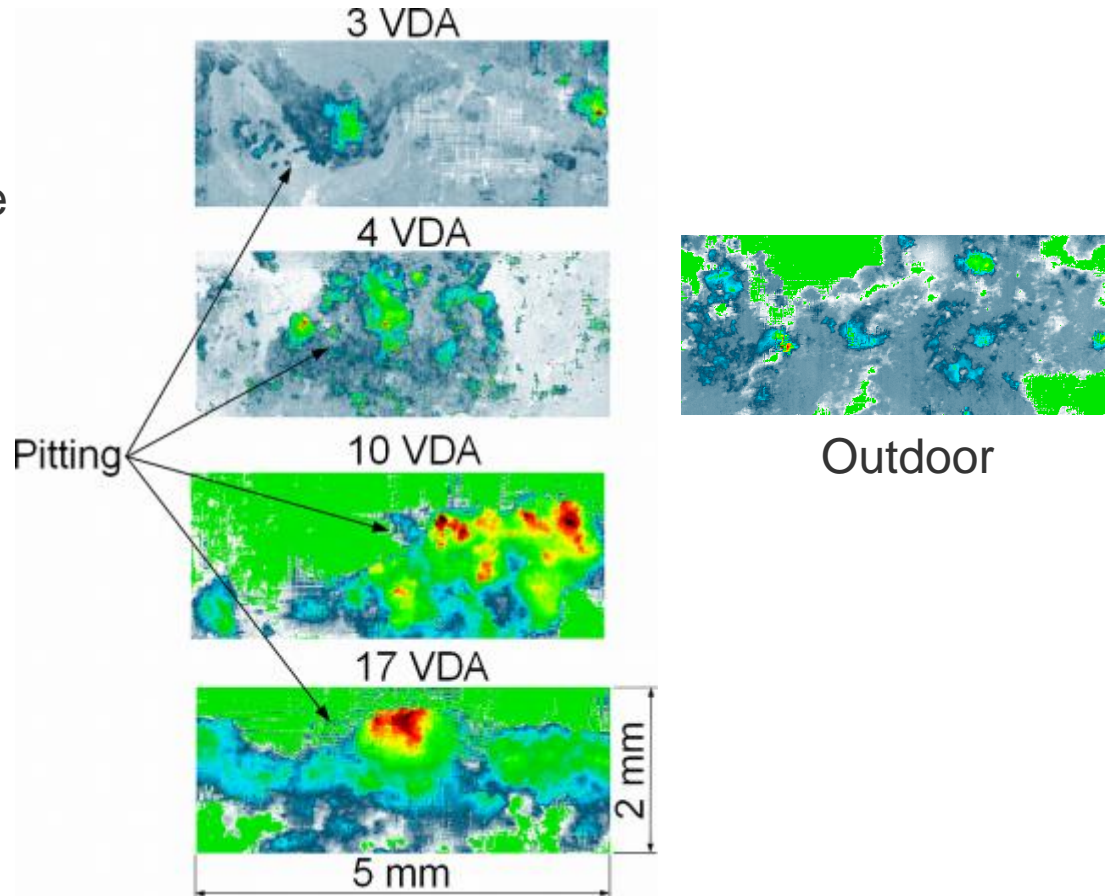
Surface scan

- Similar corrosion damage
- 1 year outdoor is more aggressive than 4 cycles indoor

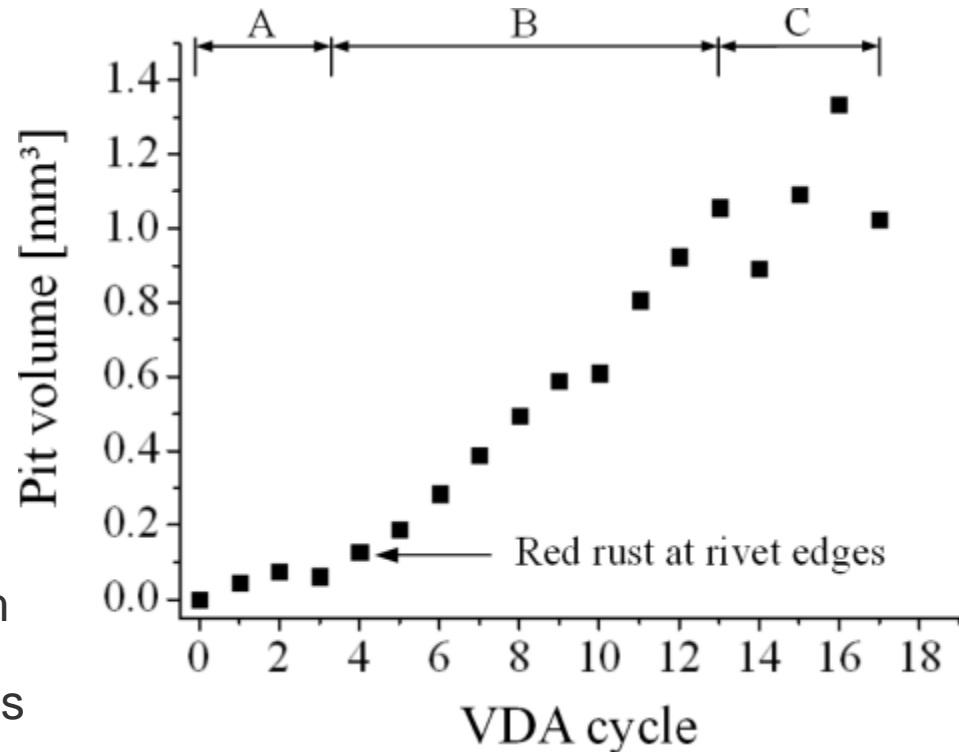
Indoor – VDA 621-415

Region A: corrosion is low

→ Pitting corrosion,
 $z \sim 0.15\mu\text{m}$

Region B: corrosion is high

→ Pitting corrosion,
 $z \sim 0.2\mu\text{m} \rightarrow z \sim 0.5\mu\text{m}$

Region C: corrosion rate decreases

→ $z \sim 0.6\mu\text{m}$

Corrosion attack as well in lateral direction → Pits coalesce

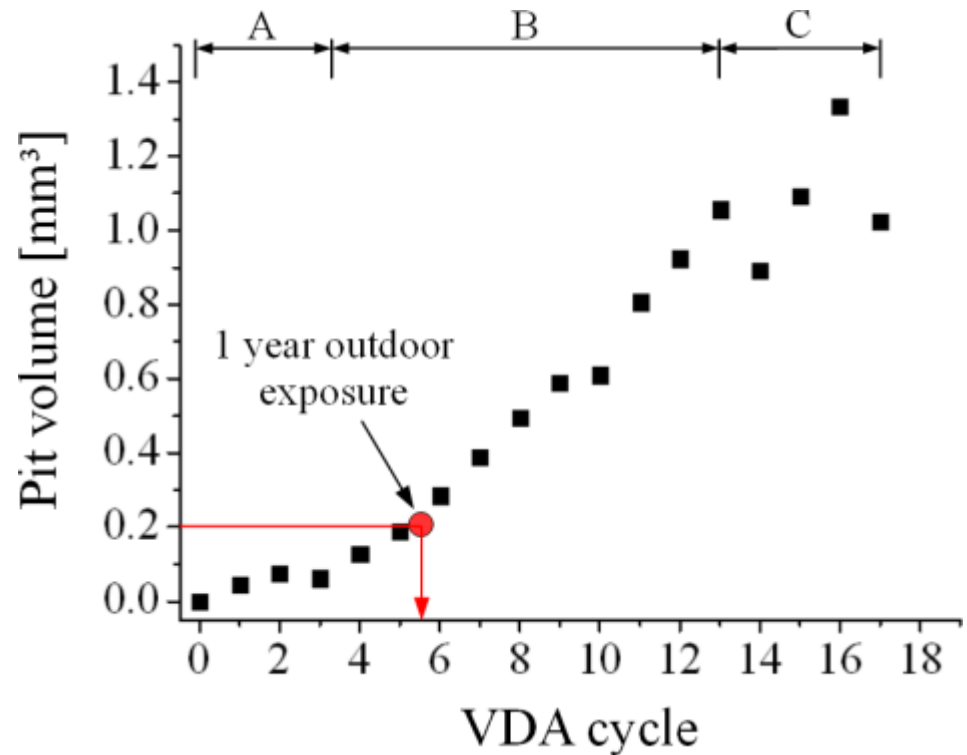
Comparison of indoor and outdoor

Corrosion attack was more aggressive than 4 cycles indoor, $z \sim 0.25\mu\text{m}$

Pit volume is equivalent to 5 – 6 cycles indoor exposure

1 year outdoor = 5 - 6 cycles indoor

→ 1 year outdoor exposure = 5 – 6 VDA 621-415
